LMR Drilling UK Ltd.

"Avon Calling..."

Bath CSO Scheme, Somerset

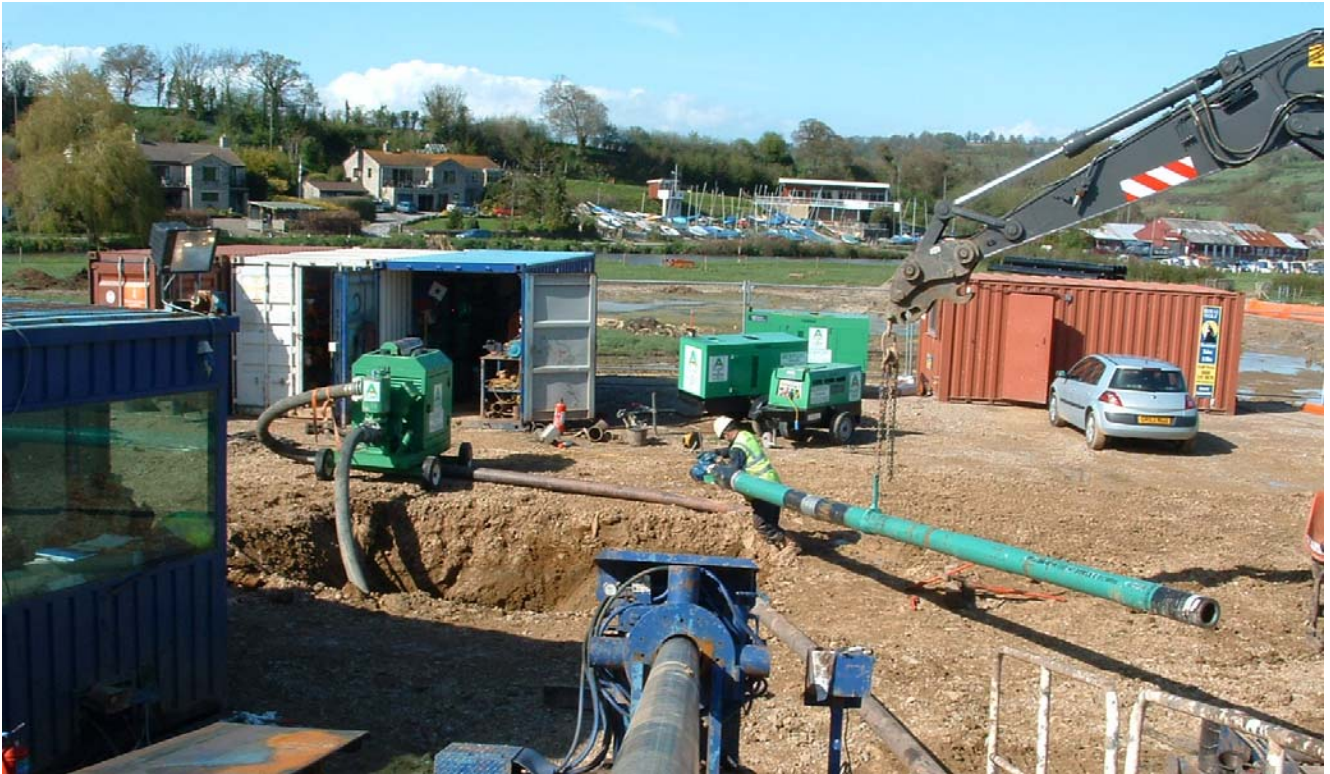
Fig. 1: View from top of Drilling Rig looking towards Exit Side (beyond tree line)

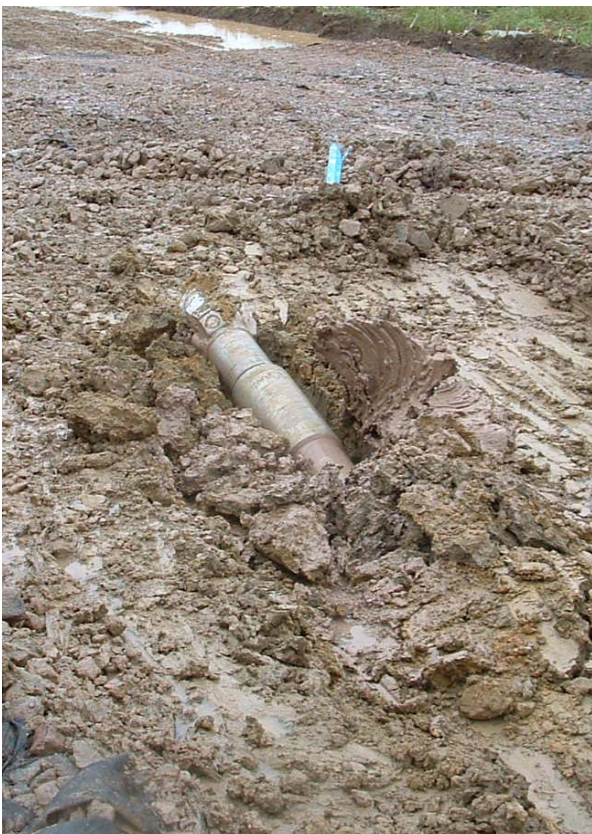
Fig. 2: The 12 ¼" Pilot Bit Breaks the Surface (the blue peg indicates the intended exit point)

Prior to punch out, the topsoil was stripped at the exit point and a pit was dug so as to collect any bentonite escaping from the bore before the punch-out was complete. Drilling continued until the bit was out of the rock and the final accuracy was to within 2 metres of the intended exit point (see Fig. 2).

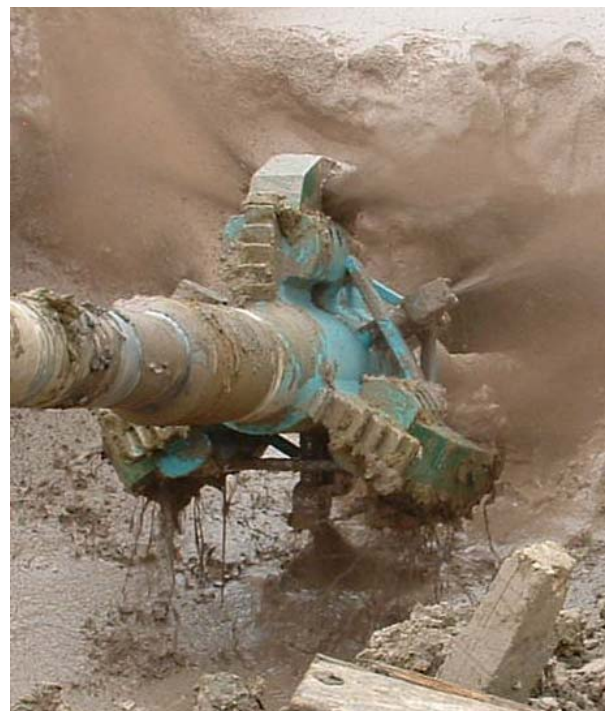
Fig. 3: The 40" Hole-Opener at the Start of the Pass

Once the 24" hole-opening was completed, a 30" and then a 40" diameter hole-opener was used to provide a sufficiently large hole in which to install the 800 mm diameter pipe.

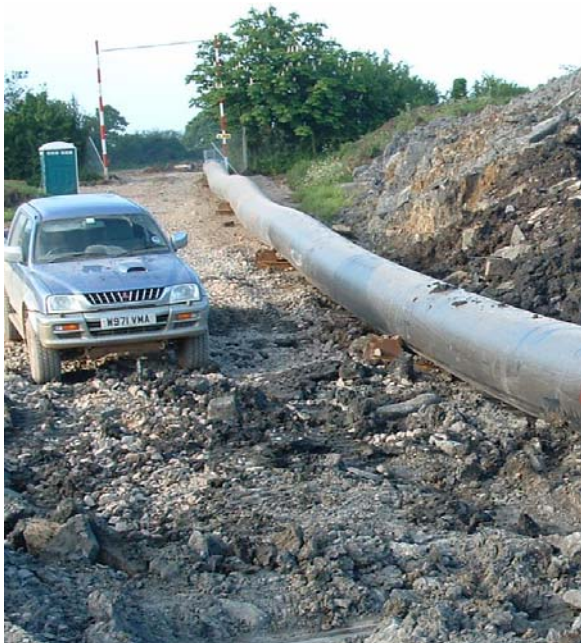
Fig. 4: The 800 mm Product Pipe on Rollers

As drilling operations were conducted, the 800 mm product pipe was butt fusion welded together (see Fig.4). A 160 mm P.E. pipe was welded alongside the main pipeline and after the product pipe was finished the 160 mm pipe was pushed into the 800 mm pipe. This was then used to fill the product pipe with water during the pullback. This water is necessary to counteract the natural buoyancy of the pipe especially in the heavier weight drilling fluid, thus reducing the pullback force.

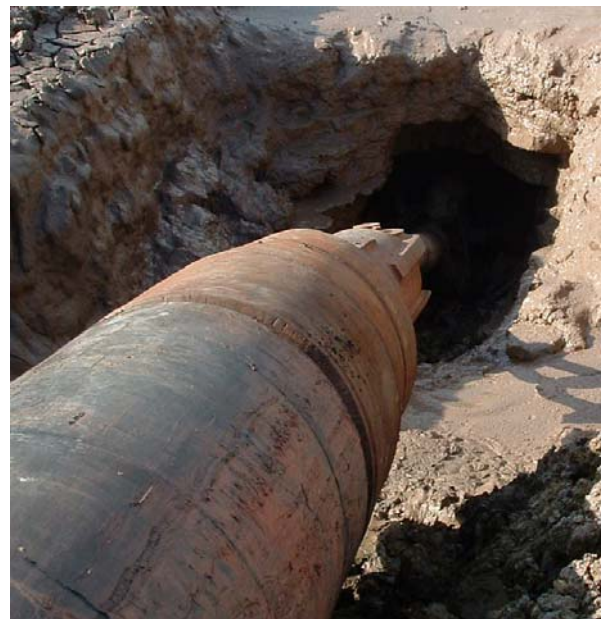
Fig. 5: Pulling Head Prior to Going into Hole During Pullback

After the 160 mm pipe was in place, stub flanges were welded on either end of the product pipe and blank plates with valves were bolted on. A pressure test was then carried out to ensure the quality of the butt fusion welding. As no welds were found to be defective, the stub flange on the end of the pipe closest to the exit point was cut off and a pulling head welded on (see Fig. 5).

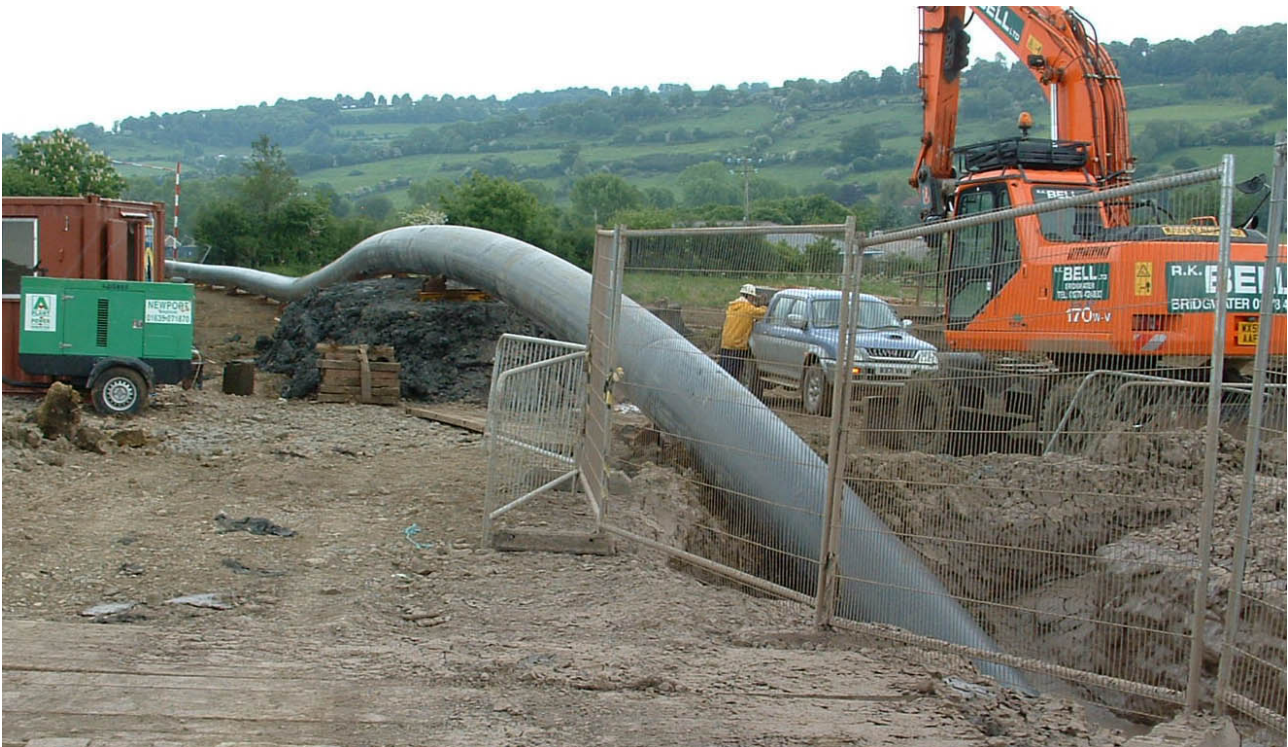
Fig. 6: Shows Product Pipe Overbend Construction

During the cleaning run with the 38" hole-opener, an overbend was constructed and this was designed to lift the product pipe to allow it easy entry into the hole. After the cleaning run the hole-opener was again attached to the drill string at the exit point.
